Manhole Inspection Summary

Manhole # S21M__034MH

Location Address: **600 s fulton st**

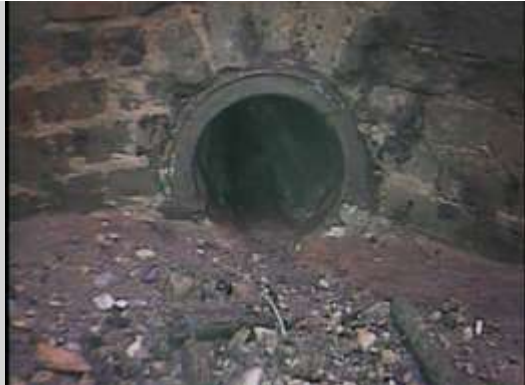
12 O'Clock Outflow

channel debris

Deposits: ☐ None ☒ **Mud** ☐ Sludge ☐ Debris ☐ Grease

Silt Depth: **1** (in.) Deposits Extent: **Light**
